NL 2C LOUDSPEAKER SYSTEM

SERVICE INFORMATION

SERIAL NO. L3C225 AND ABOVE BC4187 AND ABOVE

SERVICE BULLETIN

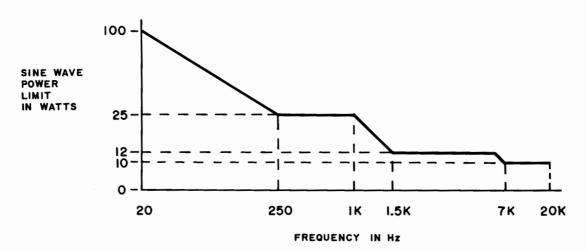
POWER HANDLING: Sine Wave steady state

Avoid operating the speaker system with sustained sine wave signals at power levels greater than the indicated limits. Permanent damage may result.

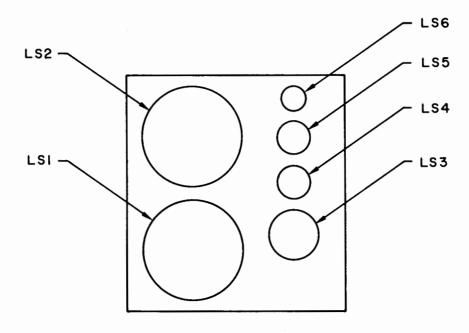
SPEAKER LOCATION

REMOVE REAR PANEL TO SERVICE CROSSOVER NETWORK

The crossover network must be inspected when burned out speaker elements are replaced. The network must also be inspected if a speaker element produces sound with the battery test but does not play when connected in the system. The woofer must be removed to get to the crossover. Check for bad connections, broken wires, etc. Be sure to check the resistors mounted on the plate underneath the printed circuit board. A broken lead on these resistors can also be the cause of intermittent or partial failure of the system.

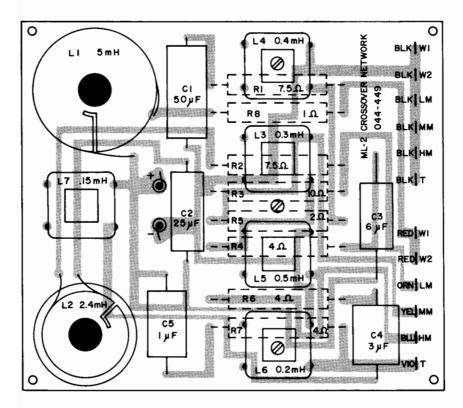
CROSSOVER NETWORK

TWO DIFFERENT CIRCUIT BOARDS HAVE BEEN USED. THE SCHEMATIC IS THE SAME FOR BOTH.

Use RTV silicone rubber under replacement parts mounted on the printed circuit board. In addition to the solder connections, this insures a vibration free bond to the board.

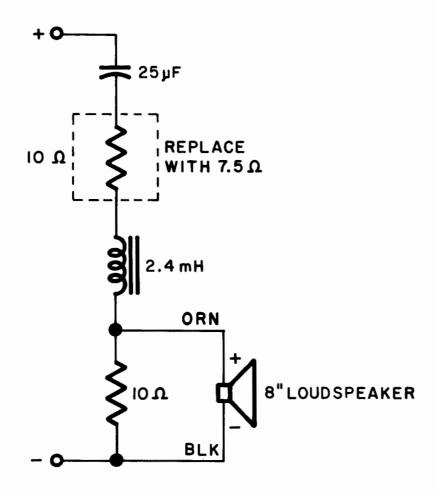
- Step 1 Remove rear panel.
- Step 2 Locate 10Ω , 10 watt resistor in series with the 8" loudspeaker. Remove and replace with 7.5 Ω , 10 watt resistor.
- Step 3 Replace rear panel.
